MILLEN LAKE DAM

NH 00236

PHASE I INSPECTION REPORT NATIONAL DAM INSPECTION PROGRAM

MARCH 1980

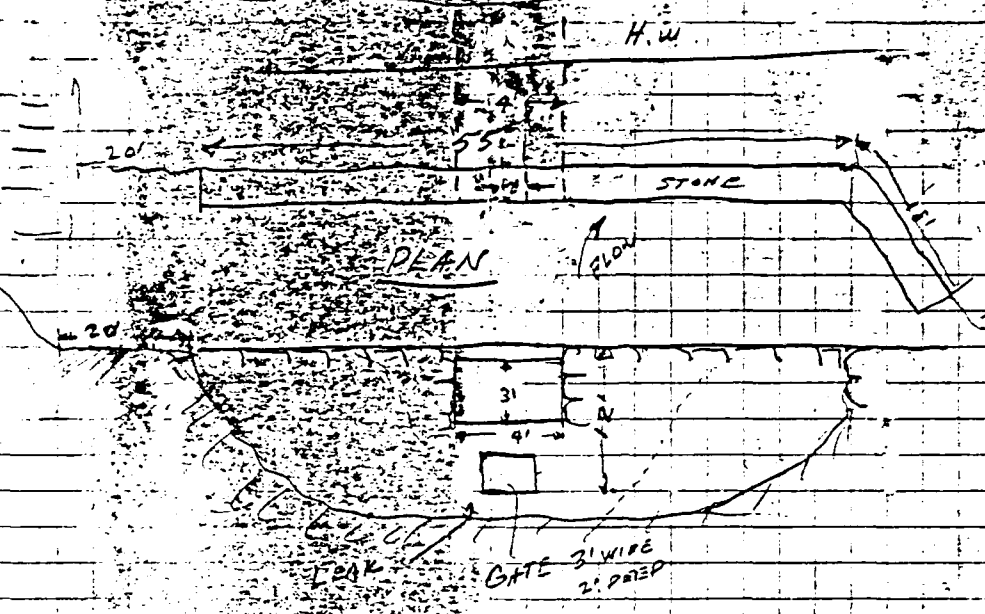
PROFILE

TYPE - STONE
 CONDITION - GOOD (LEAKS AT BASE)
 Gate raised by chain. Kept locked.

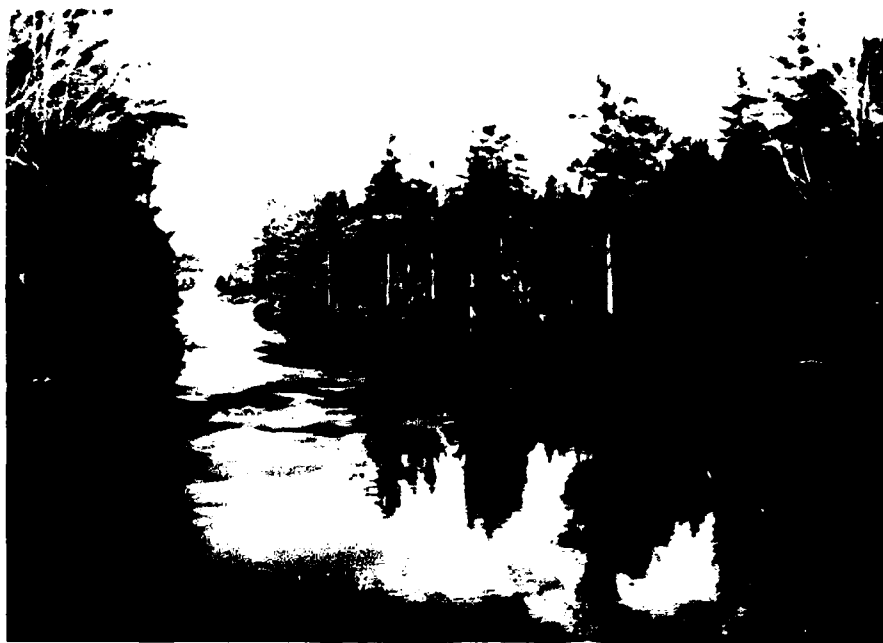
d. Reservoir Area. The slopes of the reservoir appear to be stable. No evidence of significant sedimentation was observed. Trees are growing on the banks of the approach channel upstream of the dam, but the channel is wide and unobstructed (See Photo No. 1).

Photo No. 1 - General view of lake from dam.

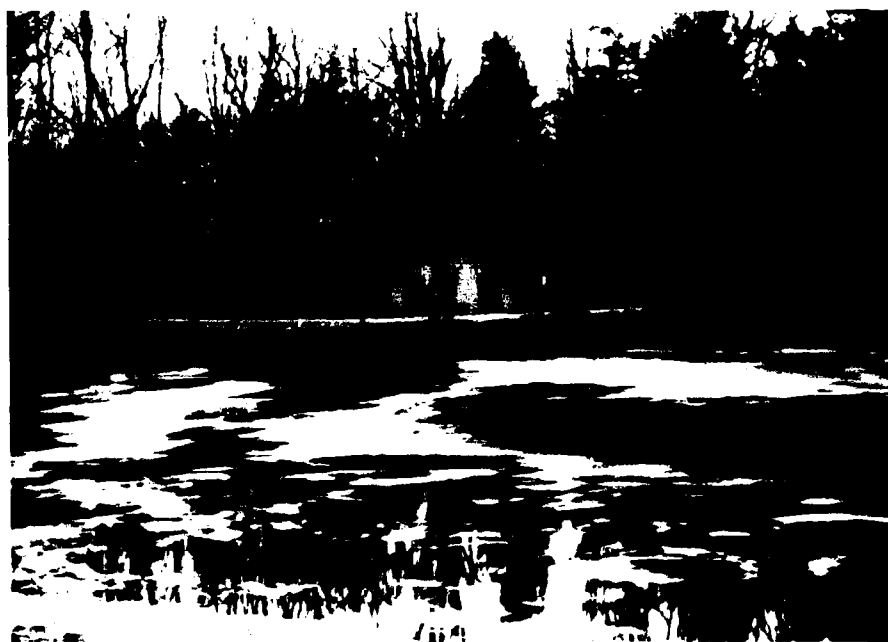
Photo No. 2 - General view of dam from lake.

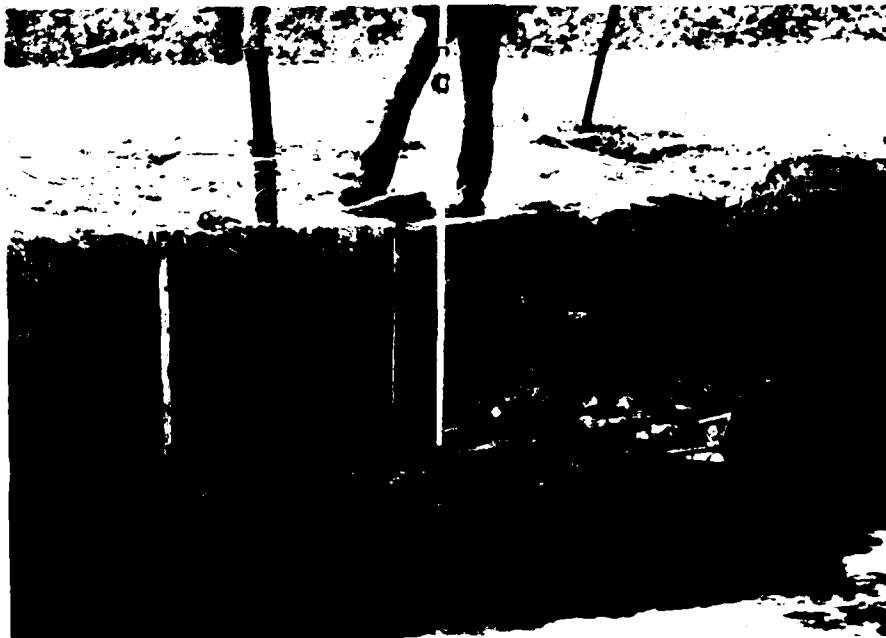
The upstream face of the dam is retained by a stone-masonry retaining wall which is in good condition. (See Photo Nos. 3, 4 and 5.) A concrete facing has been constructed against this wall up to an elevation about 4 inches above the overflow spillway crest. (See Photo No. 6 and Plans and details in Appendix B.)

Photo No. 6 - Closeup view of upstream face of spillway.
